REPLACEMENT DWELLING - ROBINS NEST FARM

SITE CONTEXT
PROPOSED
PLANNING

Scale NTS @ A3 049-0072

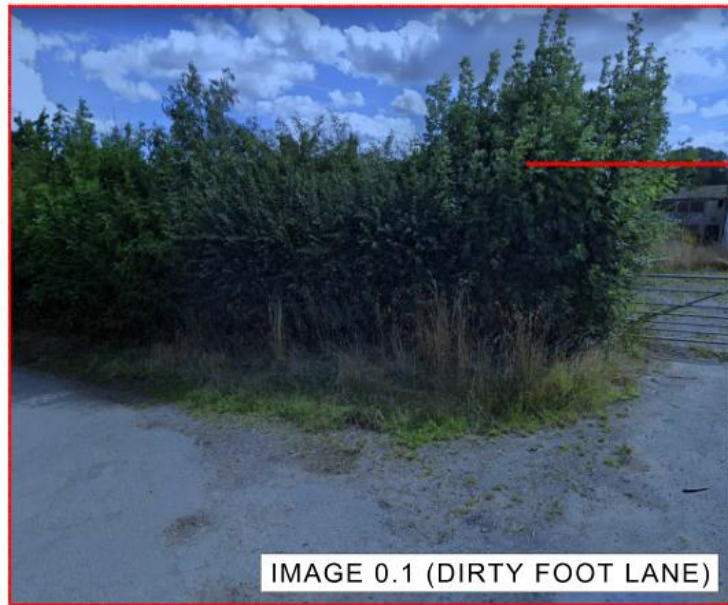
IMAGE 0.1 (DIRTY FOOT LANE)

the farm entrance is visible to the right of the image, the mature hedgerow screens the existing farmhouse and two storey barn

Image 0.1 - Front Elevation (West / Dirty Foot Lane)

The existing farmhouse and two-storey barn are entirely screened by a mature hedgerow. The hedge clearly defines the boundary of Robins Nest Farm and is well established. The proposed replacement dwelling has a ridge line lower than the existing farmhouse.

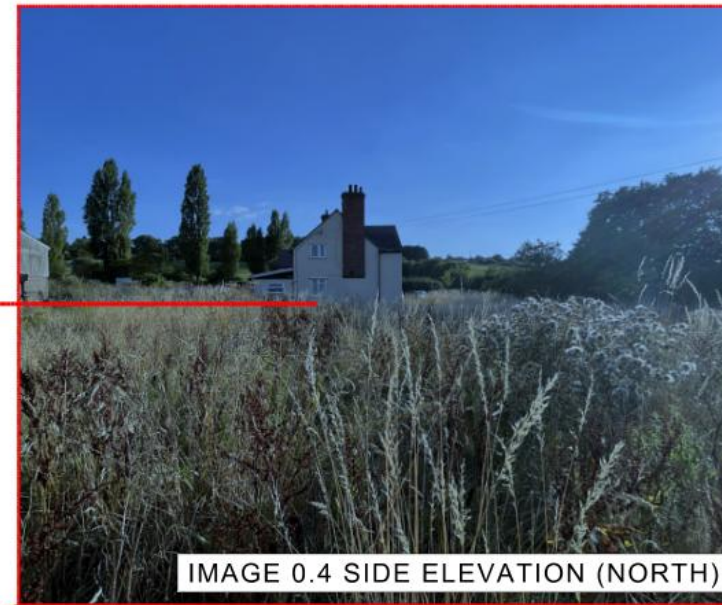
IMAGE 0.4 SIDE ELEVATION (NORTH)

side elevation of the existing farmhouse, refer to drawing 049 - 0051 for comparison with replacement dwelling, this view will be screened by tree planting

Image 0.4 - Side Elevation (North)

The view of the existing farmhouse and therefore the replacement dwelling is most visible from a northerly direction.

However the proposed dwelling is barely more visible than the existing farmhouse (refer to drawing 049 - 0051) and the difference or material effect on the openness of the green belt is negligible.

To mitigate against any exposure a significant amount of tree planting is proposed along the northern boundary in the locality of the farmhouse / replacement dwelling.

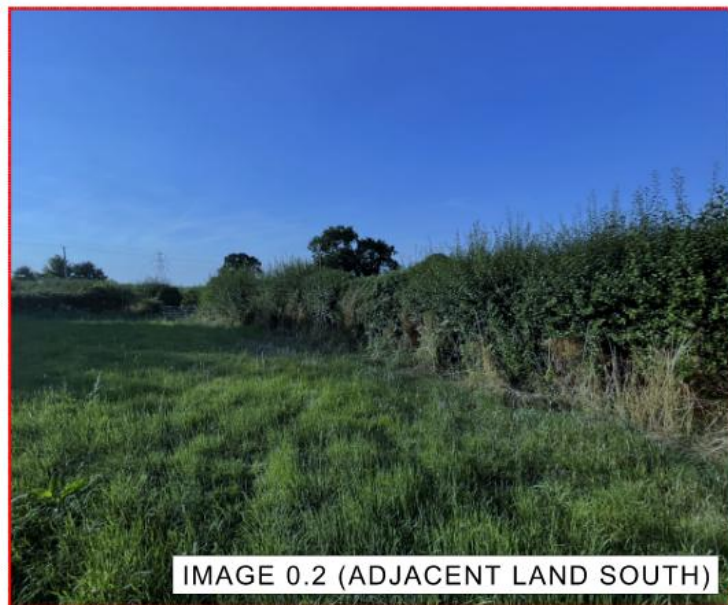
IMAGE 0.2 (ADJACENT LAND SOUTH)

Image 0.2 - Side Elevation (South)

Along the southern boundary to Robins Nest is a mature hedgerow and some mature trees. The land on the adjacent property slopes upwards towards a large and prominent dwelling on the ridge. The replacement farmhouse is somewhat remote from neighbouring dwellings and screened by the existing hedgerow.

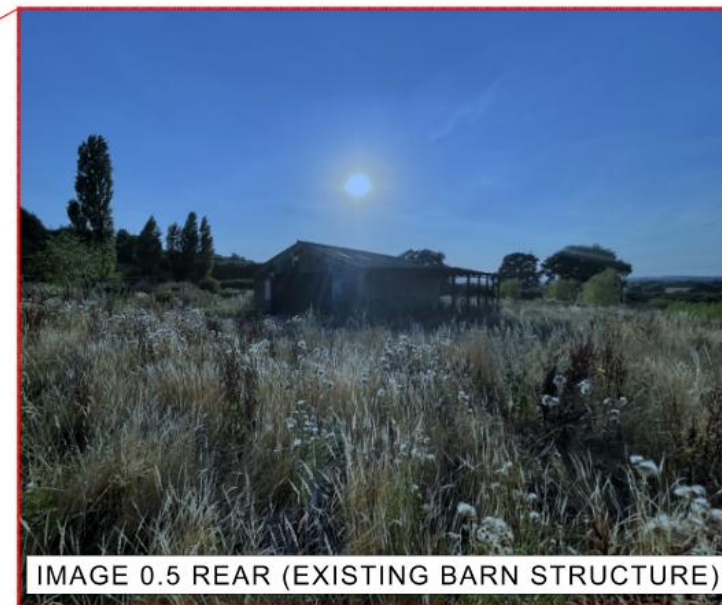
IMAGE 0.5 REAR (EXISTING BARN STRUCTURE)

Image 0.5 - Existing Barn Structure (East)

The large barn structure situated to the east side of the existing farmhouse is located at a higher ground level. The farmland rises in an easterly direction. The barn structure screens the existing farmhouse and two storey barn. It would also screen the replacement dwelling.

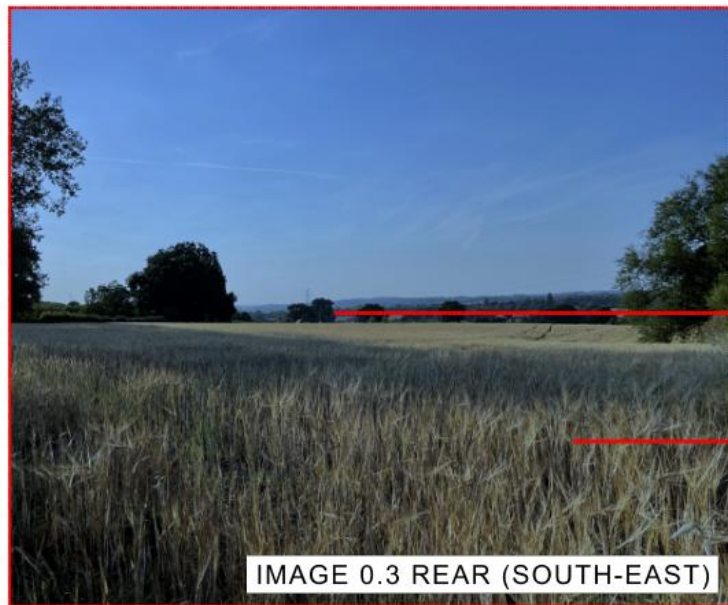
IMAGE 0.3 REAR (SOUTH-EAST)

the existing farmhouse is obscured with only the roof visible

the rising gradient of the farmland 'screens' the existing farmhouse (photo taken within the farm boundary)

Image 0.3 - Rear Elevation (South-East)

This photograph demonstrates that even within the boundary of the farm itself the impact of the existing structures is greatly diminished and barely visible.

The proposed dwelling has a lower ridge line and will appear narrower as a built form. The gap between the existing farmhouse and two-storey barn is only visible from an exact perpendicular view. The gap is lost from any oblique angle which would be the basis of the majority of the surrounding views. The existing buildings appear, when viewed from almost all direction to be larger than the replacement dwelling.

Notwithstanding this, the image clearly shows how set-down the existing buildings and thus the replacement dwelling are in the existing landscape.

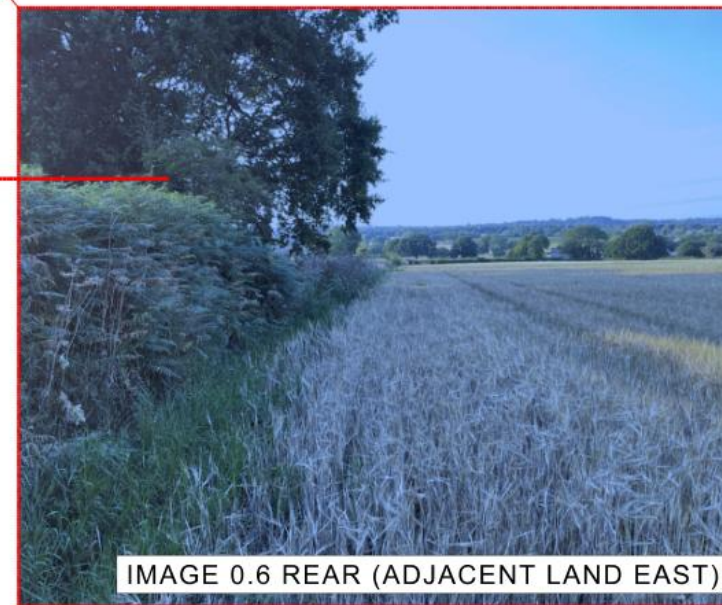
IMAGE 0.6 REAR (ADJACENT LAND EAST)

mature hedgerow than stretches the full boundary running from north to south-east, the ground also rises along the boundary

Image 0.6 - Adjacent Land (East / South-East)

Due to the orientation of the existing farmhouse the plot boundary extends from the north to the south-east of the existing farmhouse and therefore the replacement dwelling.

Along the length of this boundary is a mature hedgerow and some large mature trees in isolation. This topography screens the existing and proposed structure(s). The land rising in an easterly direction from the existing farmhouse would also serve to screen the replacement dwelling.
