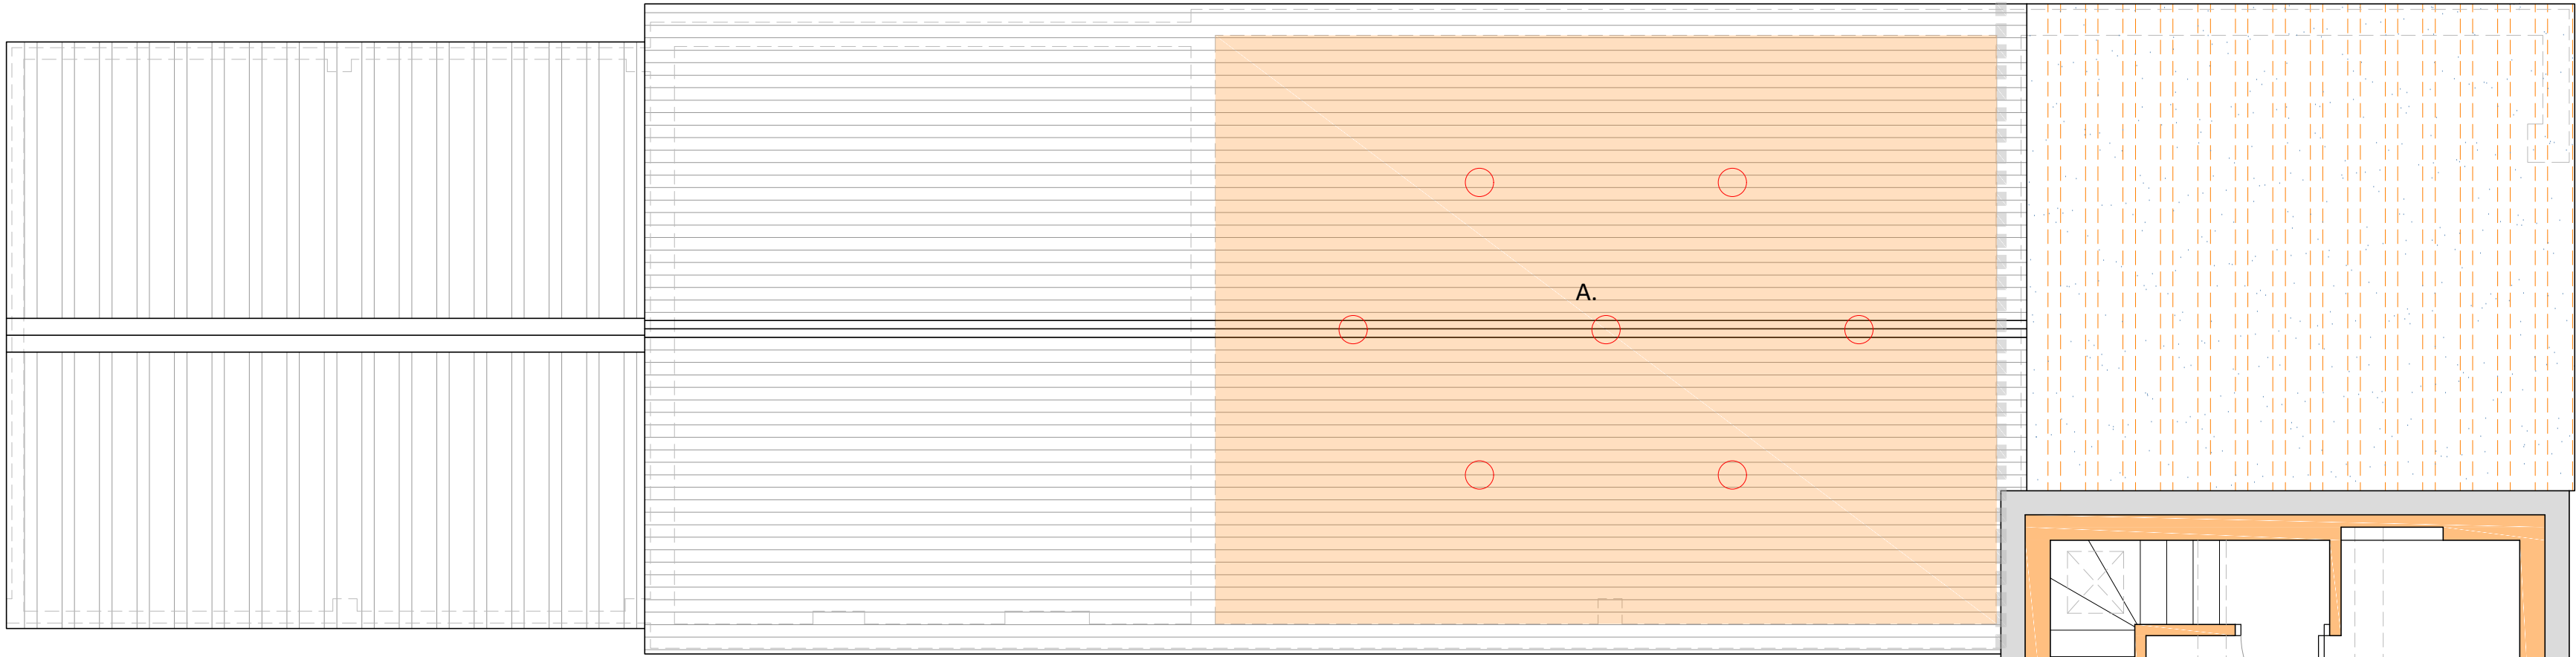
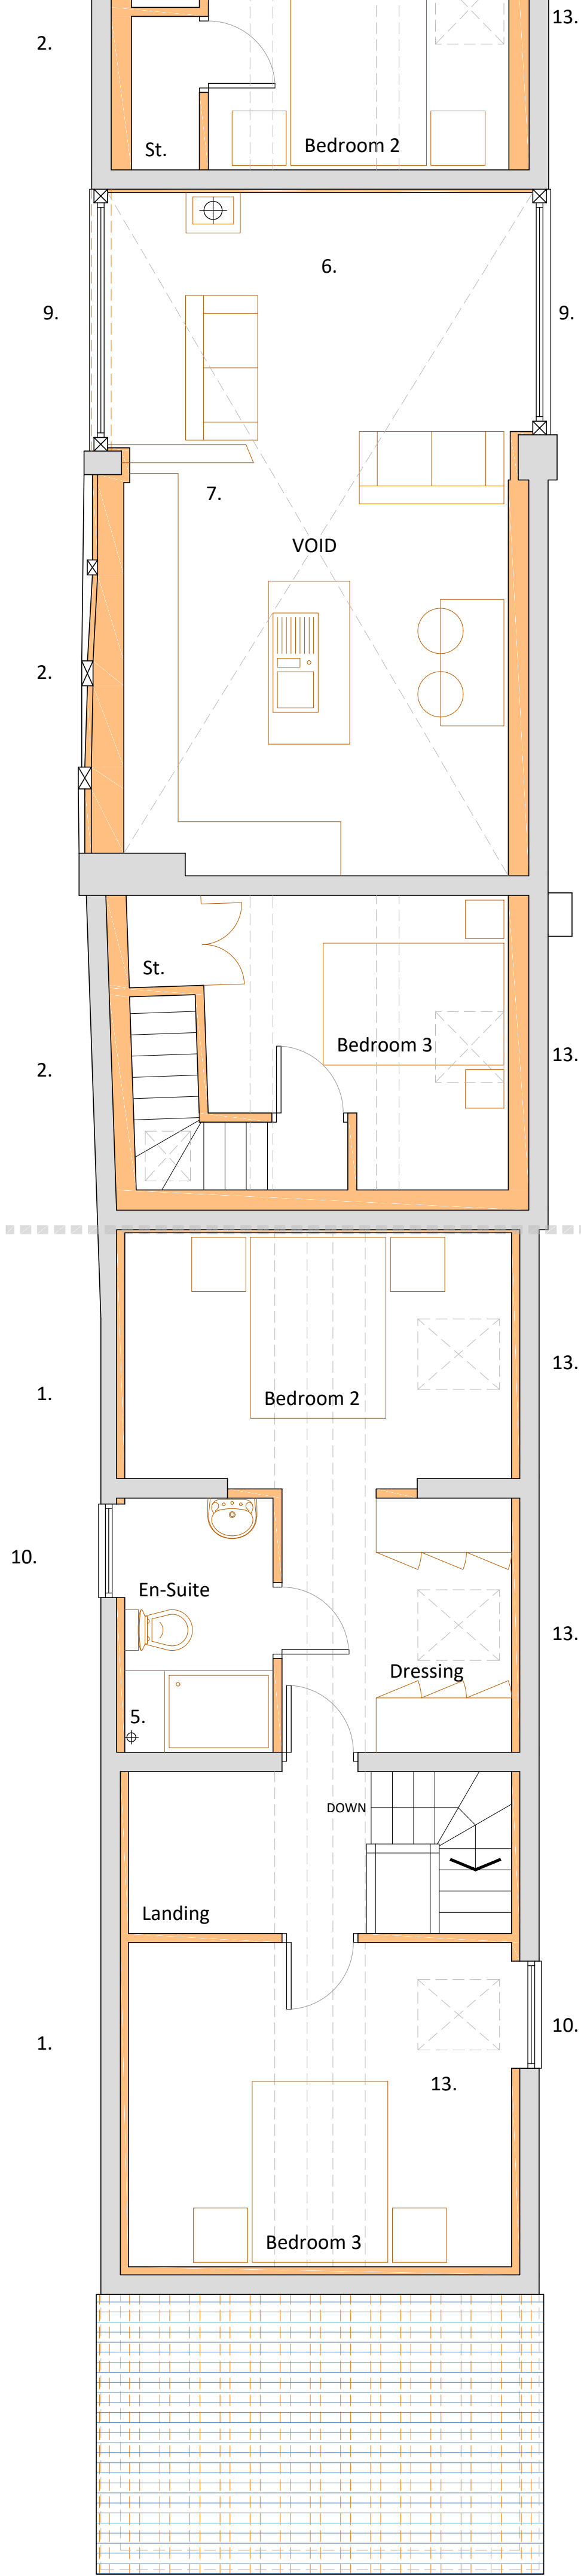
1. Existing 9" brickwork barn (Cart House) to be pointed using hydraulic lime mortar and lined internally with:
- 1.a. Lime base coat plaster
 - 1.b. 120mm "Ty-Mawr" "EcoCork board" adhered to masonry and fixed with insulated fixings,

- 1.c. Lime top-coat (finish) plaster.
2. Existing timber frame barn (Hayloft) to be lined internally with:
- 2.a. cavity, insulated with 100mm "Ty-Mawr" "Thermafleece Welsh CosyWool Slabs".

- 2.b. 100mm concrete block work, built up off new concrete underpinning. See engineers' report for details.
 - 2.c. Lime base coat plaster and lime top-coat (finish) plaster.

3. New glazed screen with central double doors in painted accoya, set in oak sub-frame in existing opening.
- 3.a. As above with bi-fold doors.
4. New external door in painted accoya.

5. New soil stack.
6. New log burner with black metal flue to ridge terminal.
7. Existing timber bracing on line of existing truss to be retained.
8. New floor drain for new island.

9. New glazed screen in painted accoya in new oak sub-frame in existing opening.
10. New external window in existing opening.
- 10.a. As above with new vertical painted timber boarding below.

11. New external window in new opening, where existing brickwork has cracked below tie bar.
12. New external window in new opening.
13. New conservation style roof light over.

14. Timber frame to be exposed externally and infilled with either;
- 14.a. reclaimed brickwork in lime mortar, tied into timber frame in every course or

- 14.b. horizontal timber cladding on a softwood frame with mineral wool insulation infill and lined internally with plywood to receive new angle wall ties for inner leaf.

- A. Location of proposed bat loft. See ecology report for construction and access details.
